STUDY OF MULTILAYER DEFECTS ON SUB-32NM HP EUV RETICLES

DIETER VAN DEN HEUVEL^A, RIK JONCKHEERE^A, TRISTAN BRET^B, MARKUS WAIBLINGER^B

A IMEC, B CARL ZEISS SMS

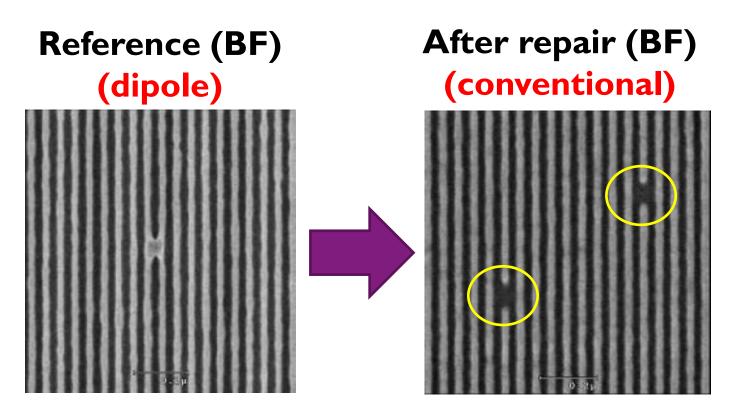
COMPENSATION REPAIR ON 27NM L/S

Note: markers only placed to be able to know exact location on wafer

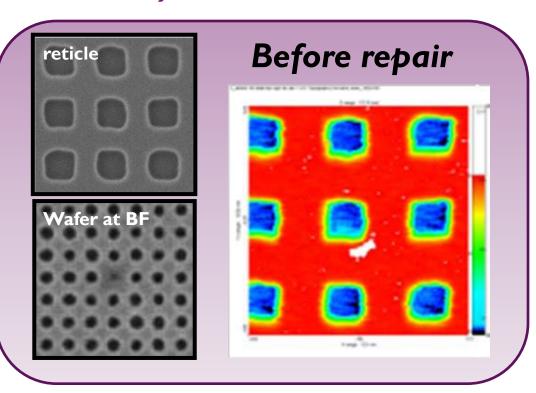
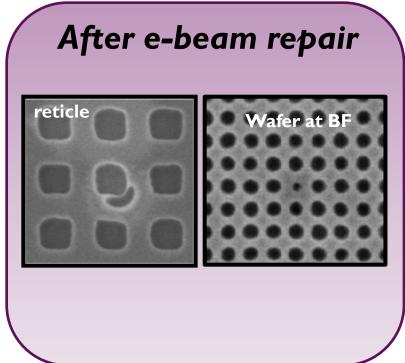
REPAIR ML DEFECTS ON 30NM CH 2) REPAIR

Observations on this example:

- Wafer print is improved, yet not satisfactorily
- Rework is possible
- **limited** compensation **process window** on this BI-found ML bump (see also presentation A. Erdmann)
